## Cauliflower

# Water Use Study Bullsbrook, Western Australia

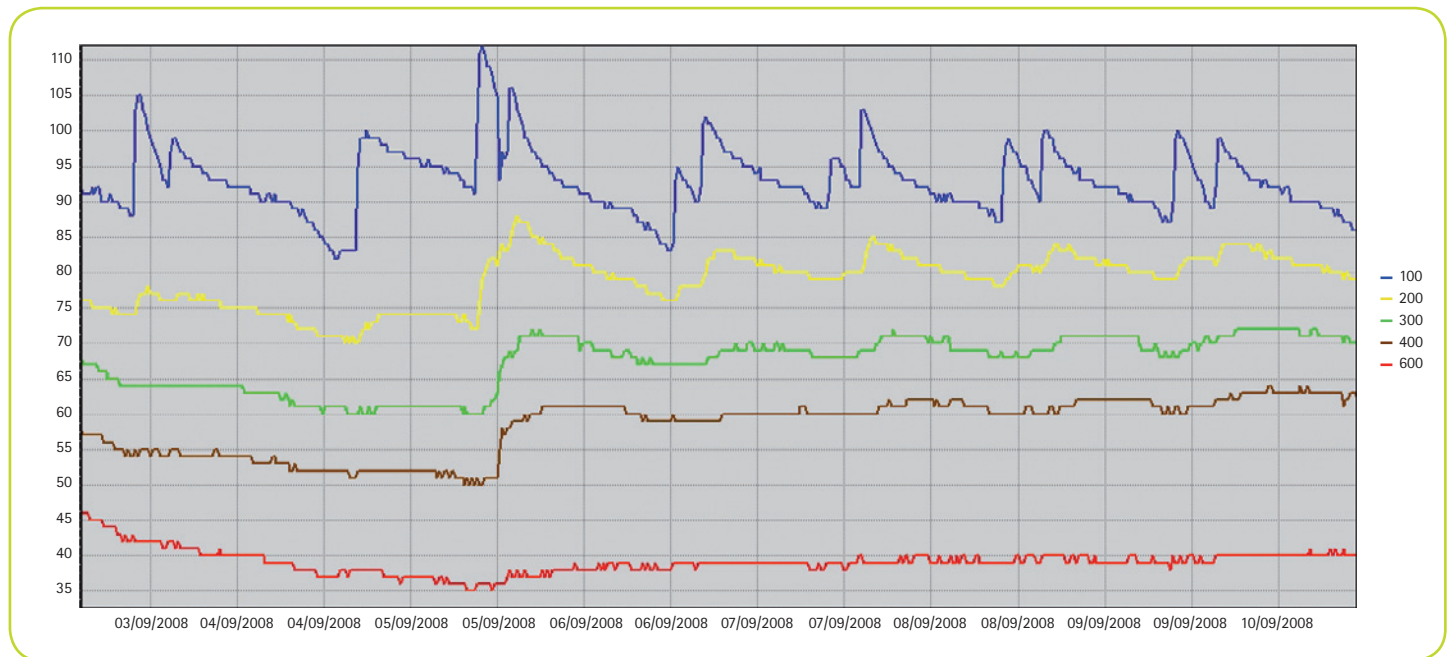
Local evaporation at the site during the month of September ranged between 23-33mm/week and significant rainfall showers were recorded during September. Irrigation was scheduled to replace 100% (1.0 crop factor) of the water lost through evaporation which was approx 3-4mm/day, which was broken up into 2 x 15min shifts/day at 9am and 2pm. Soil moisture monitoring showed that the irrigations were remaining within the top 20-30cm of soil (see soil moisture graph below). Soil moisture monitoring confirmed that water movement past 30cm can be minimized if there was approx 5 hours between irrigations. During the first 5 weeks of growth, the combined total of irrigation and rainfall was slightly greater

than the recommended water requirement for the cauliflower but water movement through to 600mm only occurred with rainfall events.

During October, evaporation averaged 5-6mm/day with a maximum of 9.6mm. At this stage the Cauliflower was 5 weeks old and the irrigation schedule was altered to deliver 120% (1.2 crop factor) of evaporation. The schedule was again altered to 140% (1.4 crop factor) for the last two weeks of growth as the crop reached maturity. As a general trend, irrigation applied was slightly lower than the recommended amount.

During the growing period, there were several rainfall events which were recorded on the property. Rainfall needs to be included when scheduling irrigations and in the total water requirement for the crop. An example of this is when 11.7mm of rain fell on the crop over the period of a week. The crop water requirement for the week was 46.1mm, so only 34mm of irrigation was scheduled for that week. Reducing irrigation after significant rainfall events will ensure that irrigation water is not wasted and crops grow in optimum conditions.

Rain: 139.4 mm

Crop Water Demand: 460.6 mm

Irrigation Applied: 355.6 mm

Total Water Applied: 495 mm

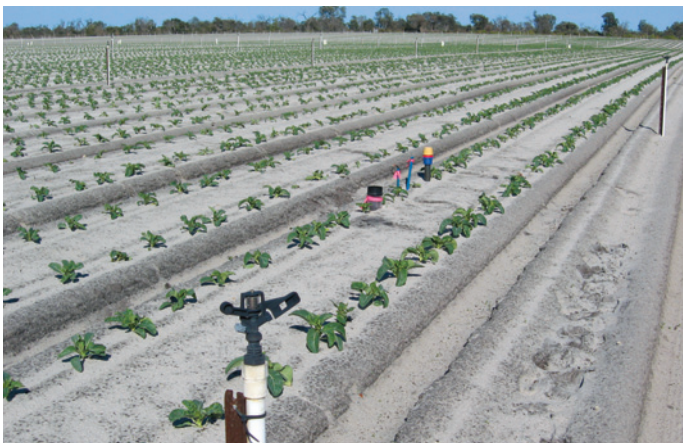
Cauliflower crop with overhead irrigation system (Naan 5022, 4 mm x 2.5 mm nozzles @ 12m x 12m spacing) with soil moisture monitoring probe in background
