Table Grape

Water Use Study West Swan, Western Australia

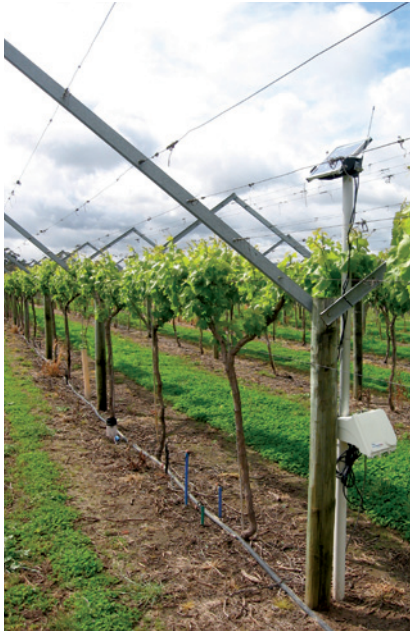
The system is designed to irrigate 5.683ha of vineyard using low volume microsprinklers for established vines and drip tape for young vines. The pump used is a Grundfos 25hp (18.5kw) Submersible feeding into 100mm A/C mainline with 50mm class 9 PVC sub-mains and 25mm LDPE lateral lines. Sprinklers used are Wingfield Challenger 1.6mm Blue nozzle with a actual flow of 151L/hr @ 210kPa in the Crimson Seedless monitoring area. Sprinkler Spacing is 6.8m between the laterals and 5.4m between sprinklers.

Row spacing is every 3.4m but the laterals are located every second row (6.8m apart). The current sprinklers have a radius of 4.8m @ 200kPa so the wetting patterns are not fully overlapping and this is reflected in the low Distribution Uniformity %.
