NON-NUTRIENT CONTAMINANTS IN THE SWAN CANNING RIVER SYSTEM

SUMMARY PAPER

March 2009

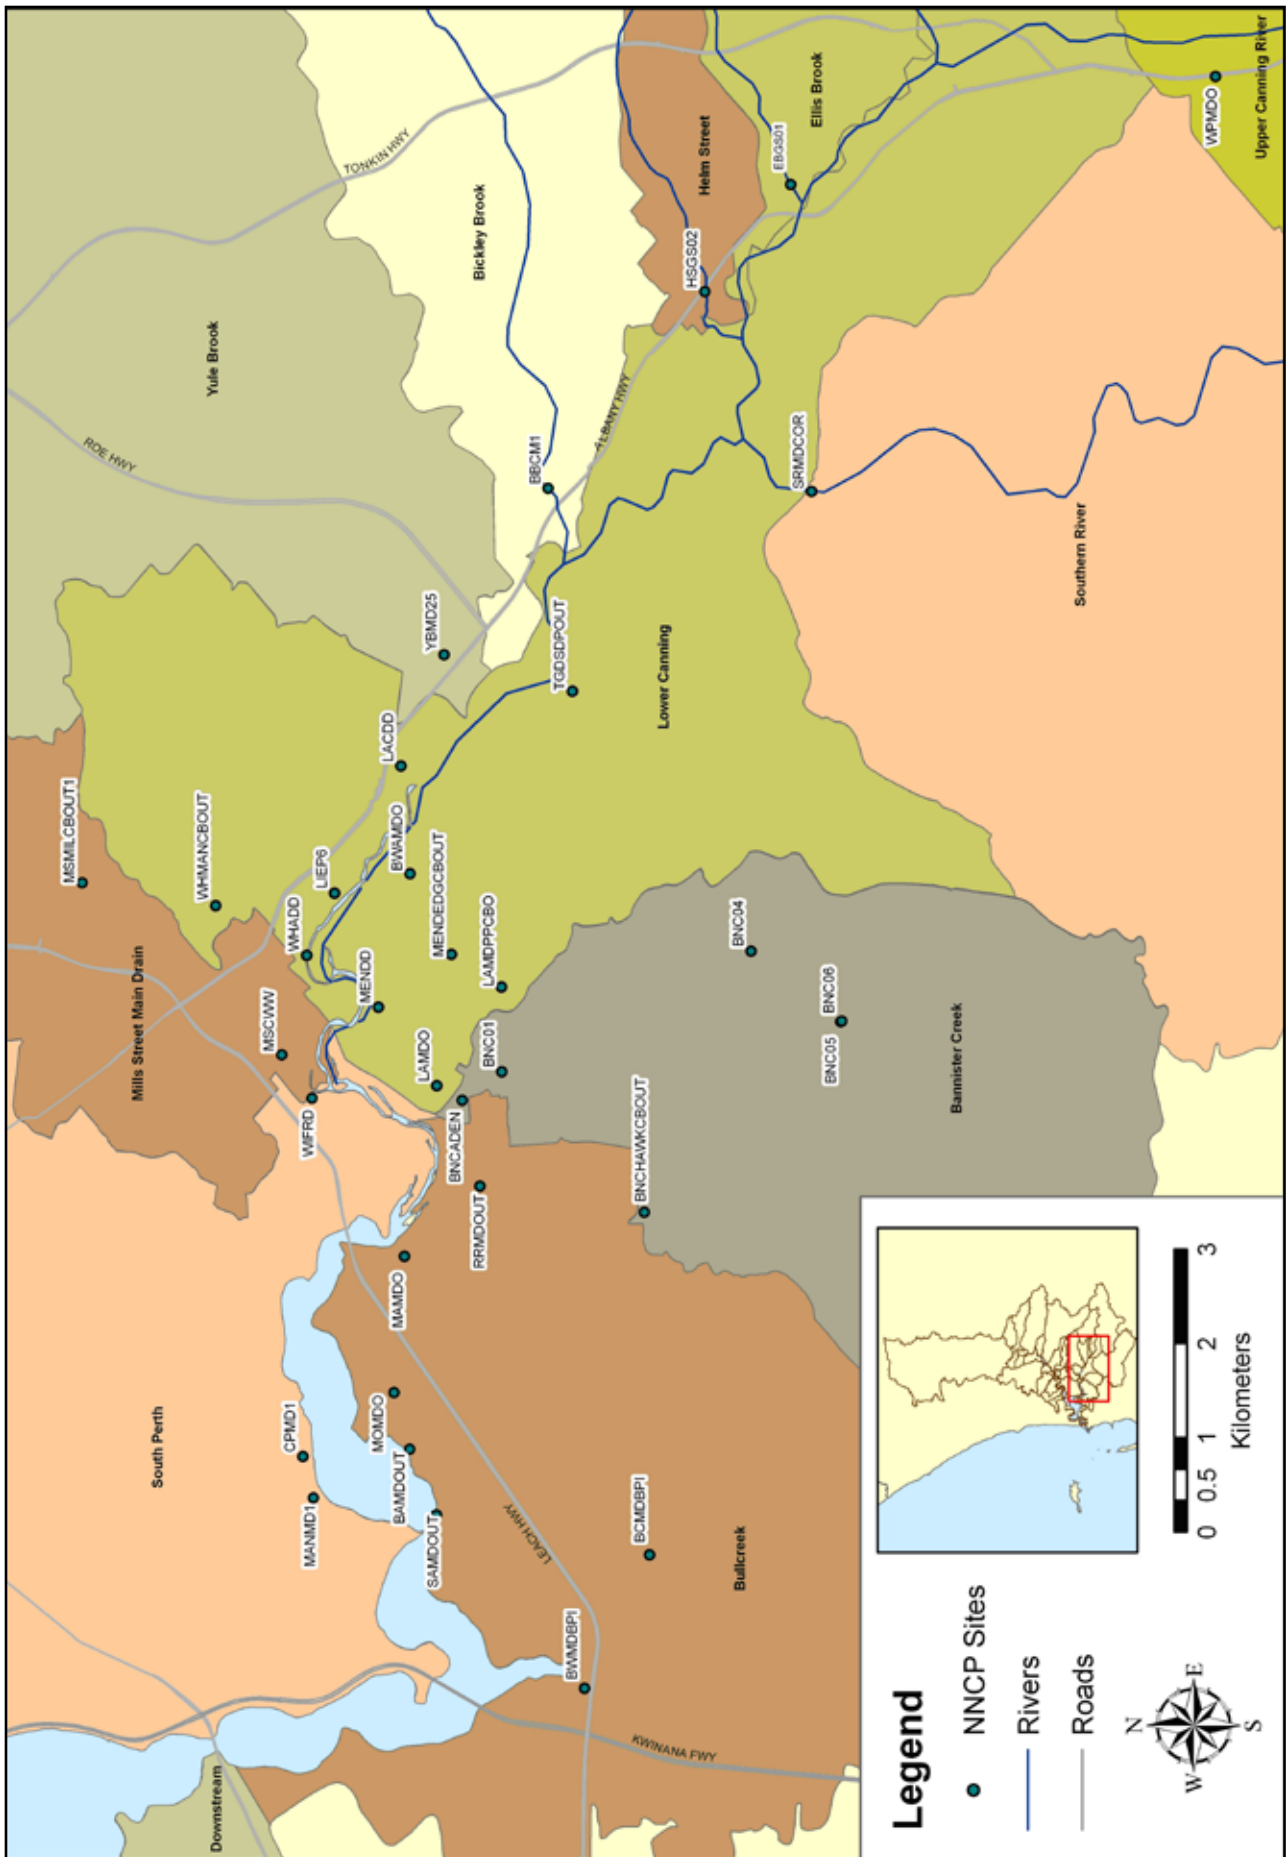
Figure 2 Drain sample sites in the Canning Catchment

During 2006, 77 individual drain sites were assessed in 27 sub-catchments (Figures 1 and 2). Surface water (grab) and surface sediment (core) samples were analysed to test for a comprehensive suite of contaminants and water quality parameters known to be associated with stormwater. These comprised: polycyclic aromatic hydrocarbons (PAHs); total petroleum hydrocarbons (TPHs); polychlorinated biphenyls (PCBs); organochlorine (OC) pesticides; organophosphorus (OP) pesticides; herbicides; anionic surfactants; metals; chromium reducible sulphur suite; microbial parameters (faecal coliforms and enterococci); major ions; and physical parameters. Representative compounds from these parameter groups were selected based on factors such as land uses in the Swan Canning Catchment, known toxicity of compounds to aquatic organisms, persistence of these compounds in the environment and the availability of current laboratory analytical techniques. In addition, nutrient parameters were assessed.

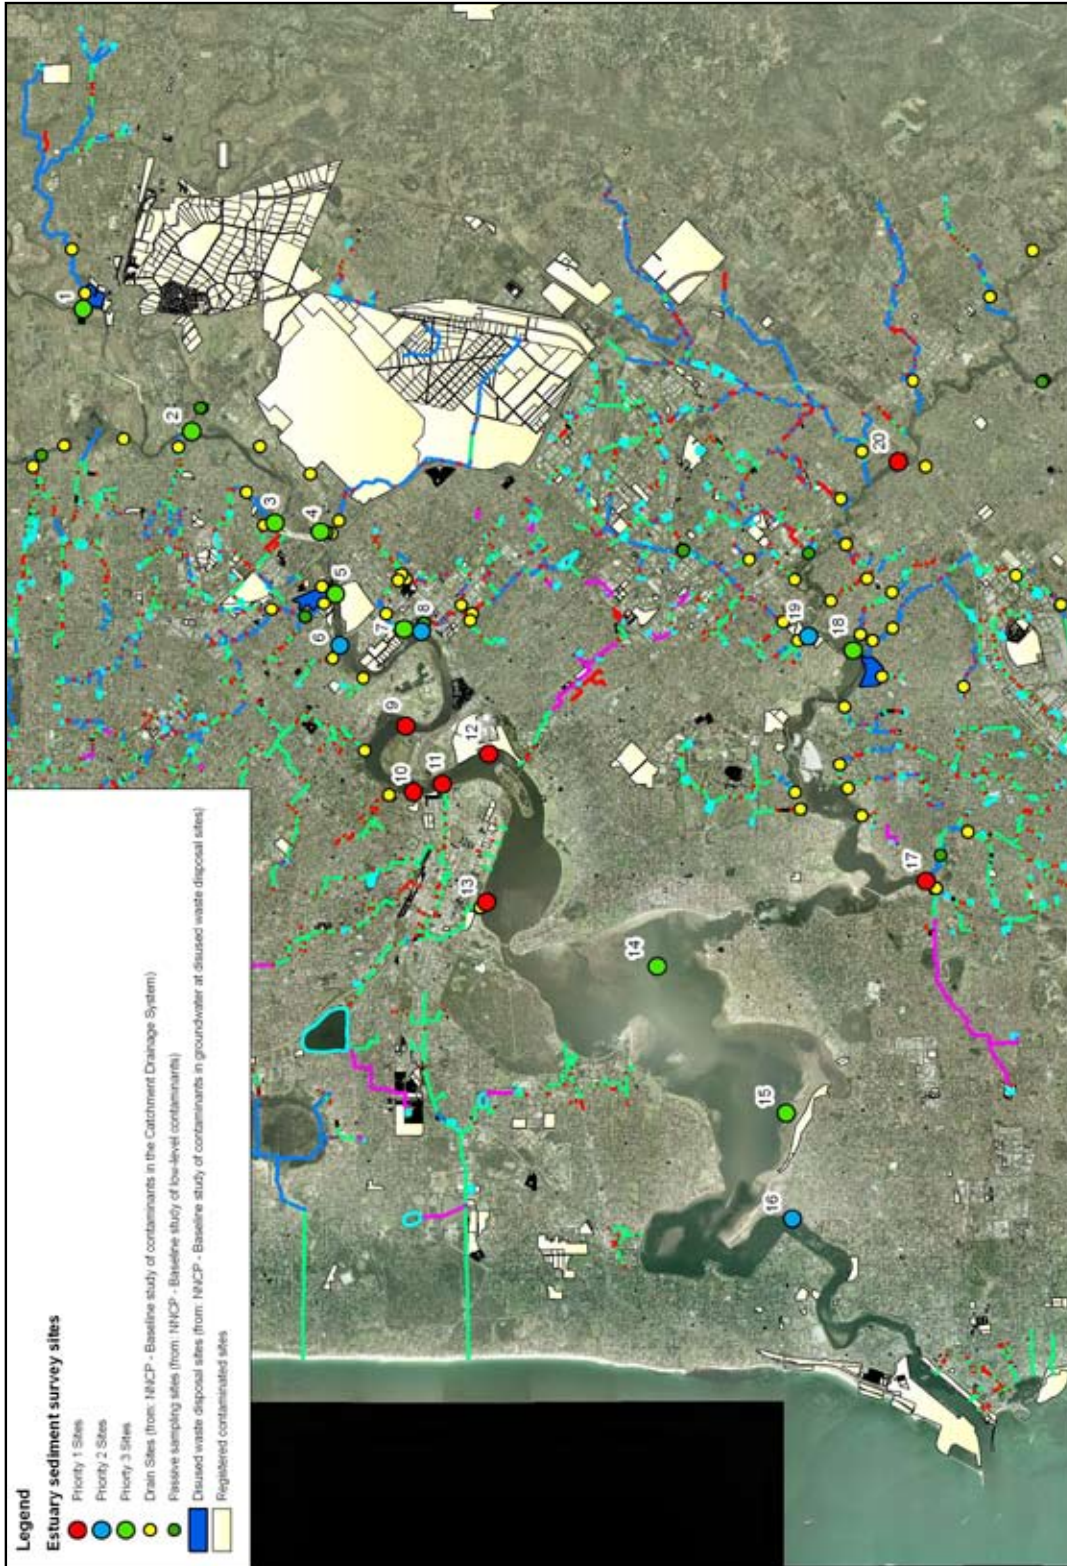
Figure 3 Site prioritisation in the Swan Canning river system

The middle portion of the Swan River comprising sites 9, 10, 11, 12 and 13 was the highest priority area along with sites 17 and 20 in the Canning River (see Figure 3). Of these seven priority 1 sites, site 11 had the greatest number of Interim Sediment Quality Guidelines (ISQGs) exceedances. A list of the contaminants of potential concern at each site is provided in Table 2.

Priority 1 sites
 >3 contaminants exceeded the ISQG Low Trigger Value and/or any number of contaminants exceeded the ISQG High Trigger Value

Priority 2 sites
 1-2 contaminants exceeded the ISQG Low Trigger Value. No contaminants exceeded the ISQG High Trigger Value

Low priority sites
 Contaminants present at levels below ISQG Low Trigger Values

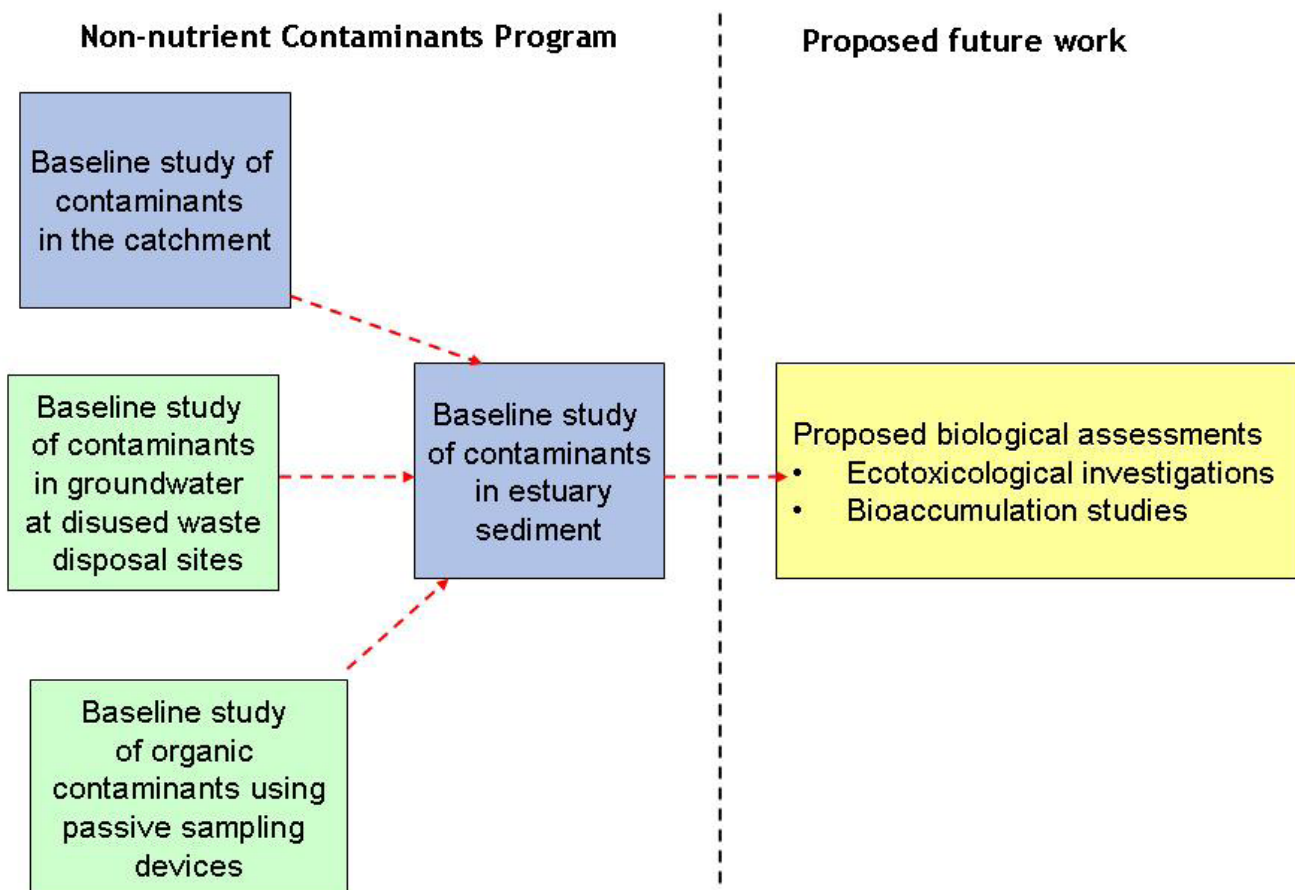
Figure 4 Multiple lines of evidence to determine the impact of contaminants on the Swan Canning river system

By incorporating ecological, ecotoxicological and chemical studies in an assessment of the impacts of non-nutrient contaminants (Figure 4) on the Swan Canning river system, a “weight-of-evidence” approach can be applied, the underlying principle of which is that multiple lines of evidence reduce uncertainty in impact assessments (Chapman et al 1997).
